IN THE COURT OF APPEAL OF THE REPUBLIC OF SINGAPORE

[2023] SGCA 20

Court of Appeal / Civil Appeal No 45 of 2022

[Admiralty and Shipping - Collision]

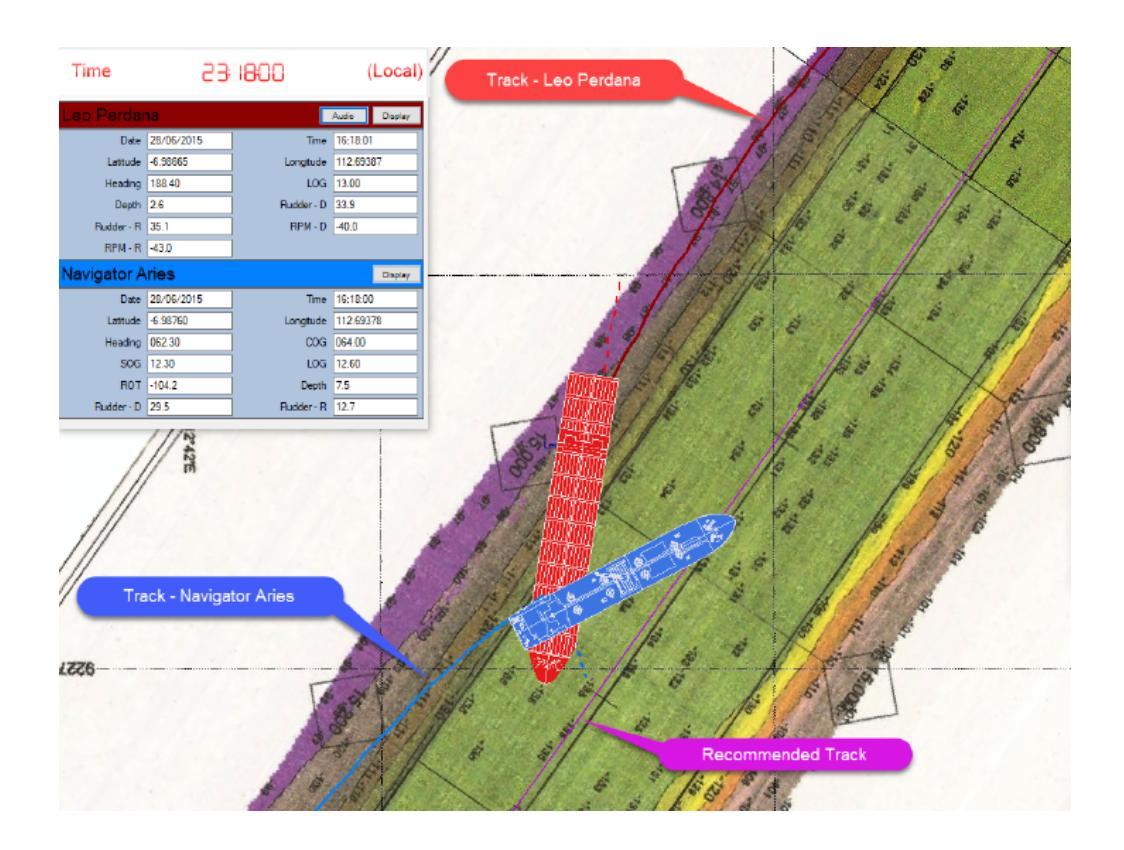
The manoeuvres undertaken by both vessels ultimately failed to prevent the collision from occurring. By 23:17:30 hours, the vessels were only about 0.1nm apart and closing at a combined speed of about 28 knots. The vessels' initially uneventful voyages underwent a sea change with the port sheer, with the *LP*'s heading changing from 222.9° at the time the sheer commenced at 23:16:46 hours, to 198.6° at the time of the collision at 23:17:51 hours (*ie*, she went to port by 24.3°). At 23:17:51 hours, the *LP*'s bow struck the *NA*'s port side at an acute angle. The angle of the blow is illustrated in the AIS <u>plot</u> below:

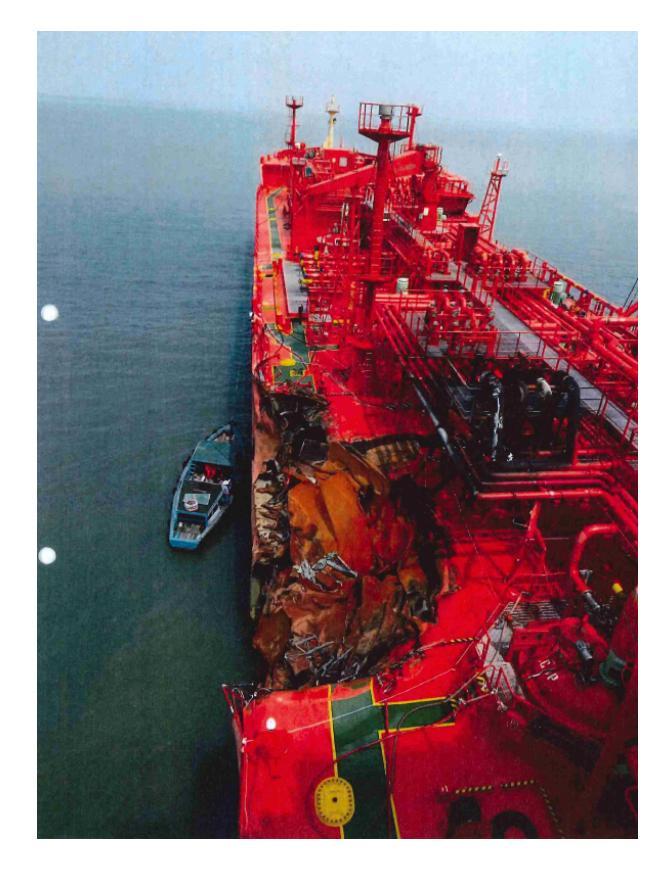
37 The actual impact of the blow is also captured in this photograph of the *NA* taken post-collision:

38 Seconds after the collision occurred, the *NA* suffered a cargo fire and began drifting in a northerly direction. The *LP* moved astern to pull away, and the vessels separated by around 23:19 hours. The *LP* then proceeded on a northerly course that brought her beyond the western edge of the Dredged Channel.

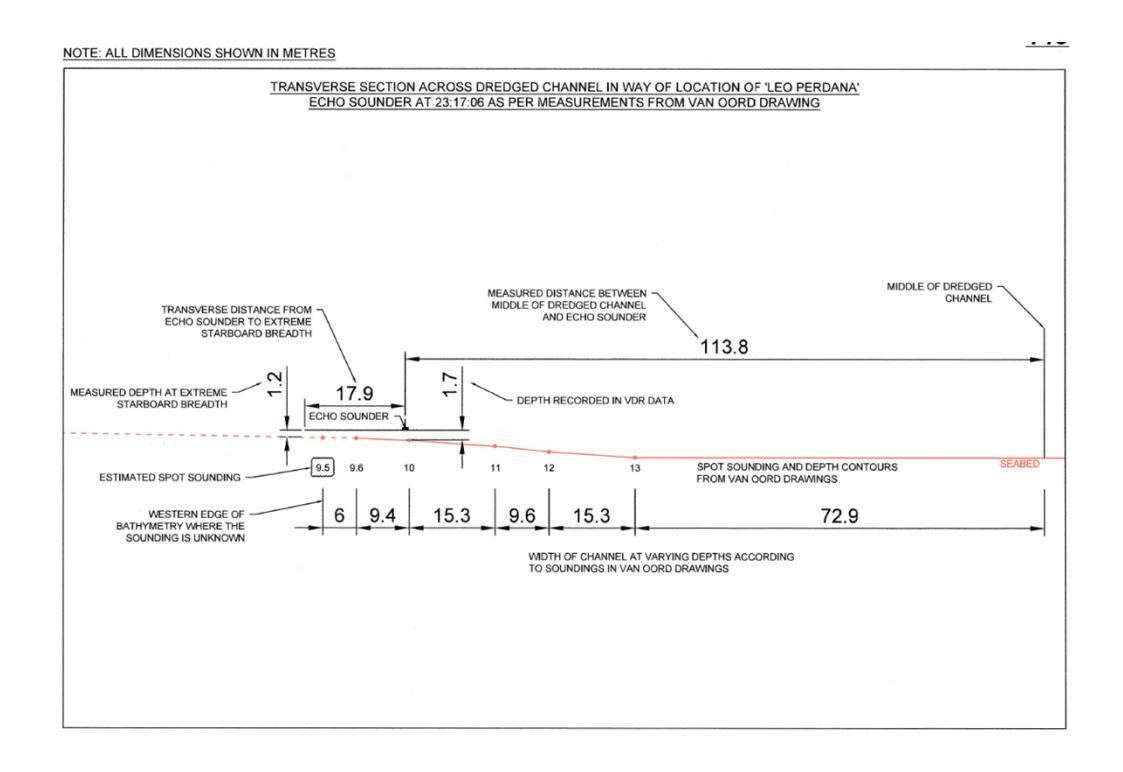
66 The Judge had instructed parties to provide estimates on the water depths on the starboard side of the *LP*'s hull at the time the port sheer occurred, based on her echo transducer data. The parties' experts submitted the following diagram, showing a UKC of 1.2m on the *LP*'s starboard side and 1.7m UKC on her port side. We accept that this differential provides the conditions for bow cushion effect to arise.

To be clear, the port sheer occurred at 23:16:46 hours. The reason the above diagram refers to measurements taken at 23:17:06 hours is that there was a lag of about 20 seconds between the time the LP's bow would have crossed a given spot on the seabed, and the time her echo transducer would have crossed that same spot. This is because her echo transducer was some 147m aft of the forward perpendicular. A 20 second adjustment was thus applied to estimate the LP's UKC at 23:16:46 hours.
