Airtrust (Hong Kong) Ltd v PH Hydraulics & Engineering Pte Ltd  
[2015] SGHC 307

**Case Number** : Suit No 219 of 2013  
**Decision Date** : 30 November 2015  
**Tribunal/Court** : High Court  
**Coram** : Chan Seng Onn J  
**Counsel Name(s)** : Tan Chuan Thye SC, Avinash Pradhan, Alyssa Leong and Arthi Anbalagan (Rajah & Tann Singapore LLP) for the plaintiff; Daniel John and Kevin Cheng (Goodwins Law Corporation) for the defendant.  
**Parties** : AIRTRUST (HONG KONG) LTD — PPH HYDRAULICS & EENGINEERING PTE LTD

*Commercial Transactions – Sale of Equipment – Breach of Contract*

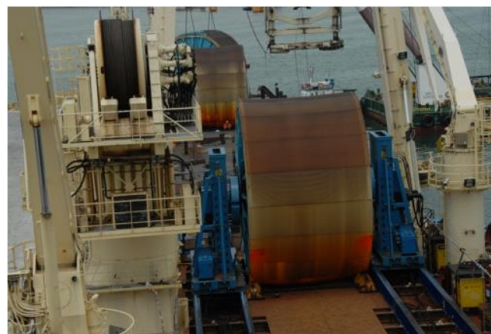
2 In 2007, the Plaintiff purchased a 300 tons reel drive unit ("RDU") from the Defendant. Attached below is a photograph of the RDU that was fabricated by the Defendant. The photograph shows a 300 tons reel (brown in colour) sandwiched between the two towers of the RDU (blue in colour) mounted on skids (blue in colour) on the deck at the aft of the ship, the "Maersk Responder".

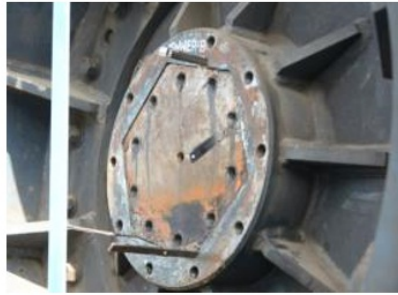
Gear side of Tower B

87 The shaft end plates provide attachment of both the main gear and the hub drive insert to the main driveshaft between the gear and the reel hub. Ten M20 x 55 mm, grade 8.8 bolts attach the plate to the hub/gear, with a further ten bolts of the same specification attaching the same plate to the shaft.

88 Dr Eccles explained in his AEIC from pp 9 to 33 why the bolting arrangements on the shaft end plates were inadequate. At the hot-tubbing, Dr Eccles calculated that if the brakes were applied to slow down the 300 tons reel spinning at 0.29 rpm, corresponding to a lay speed of 500 m per hour, it would cause the bolts at the drive shaft end plates to be overloaded. With the clearances present, measuring about 1.3mm to a maximum of 2.5mm, between the hexagonal shaft and the gear on the one end and the reel insert on the other, the bolts would come loose. Mr Hooper disagreed with Dr Eccles and asserted that the hexagon in the hexagonal shaft took the shear load/torque transmission and not the bolts which merely held the gear hub in place. However, the hexagonal shaft would be able to take the shear load only if the clearances were absent and the hexagon fitted tightly within the hub. Mr Hooper then speculated that *"it may have been that on the end of the hexagon, there was a slight taper put on in order to get the hub to fit on..."*, which then took up all the clearance on the hexagonal section.

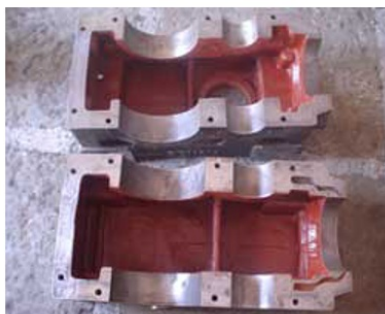
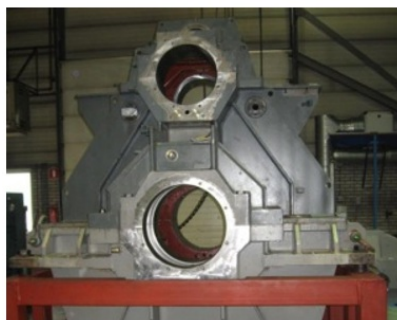
116 Mr Moore noted that the RDU's bearing housings were being supported and located by the bolts. In his view, heavy-duty fabricated structures are normally used to support such a drivetrain. The bearing housing is usually designed to be an integral part of the fabrication. This negates the need to rely on the bolts to attach the bearing housing to the main fabrication. In such cases, the item would be designed and manufactured as a casting or heavy-walled fabrication and would also incorporate strengthening members as part of its design. This ensures sufficient local rigidity and support of the loading experienced by the pinion bearing and provides a means of load transfer into the sub-frame fabrication which in turn transfers its load into the main support towers. Further, the bearing is normally located directly into the heavy walled structure via a very tight clearance fit. This

provides a rigid base to seat and support the bearings whilst under load and provides an accurate machined datum, consequently giving better alignment of the bearing to the outboard mounting of the pinion. A similar arrangement is also appropriate for the bearing housing for the main driveshaft. This is critical to ensure correct alignment of the pinion gear to the spur gear. A similar arrangement appropriate for the bearing housing for the main driveshaft is also critical to ensure correct alignment of the pinion gear to the spur gear. In his report, he showed the following examples of correctly designed bearing and gearbox housings.

117 In the light of Mr Moore's criticisms of the design from a conceptual perspective, Mr Hooper conceded that the whole bearing housing could be better designed and it was "*definitely not an optimum housing arrangement.*" In fact, the Defendant had shown no technical justification from departing from what one would normally expect for such a design. There are no calculations or engineering analyses on record in the Defendant's possession that would support the sufficiency or structural robustness of the Defendant's design. I therefore find that the Defendant had not given due consideration to whether the bearing housing was appropriately designed *at the time it was designed.*

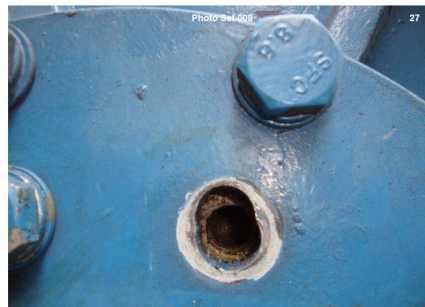
Figure 53: Elongation of holes due to initial incorrect positioning

174 From the photographic evidence, it is clear to me that the bolt clearance holes in the sub-frame end plate were badly drilled evidencing poor manufacturing practices. It would appear that there were machining errors with misalignment in the original hole pattern and re-drilling had to be done at the component fit up stage so that the bolts could be screwed into the threaded holes. Mr Philip Chua confirmed that the pre-drilling was done in China. During the assembly of the parts in Singapore, re-drilling was done if the bolts could not match the clearance holes.

175 The Plaintiff submits that the re-drilling modifications would exacerbate movement of the component, especially when combined with insufficient bolt pre-loading and would not be acceptable especially for a component that was critical to ensure the secure attachment of critical gear drive components. I agree.
