**IN THE HIGH COURT OF THE REPUBLIC OF SINGAPORE**

**[2017] SGHC 246**

**JUDGMENT**

**Smile Inc Dental Surgeons Pte Ltd**  
v  
**OP3 International Pte Ltd**

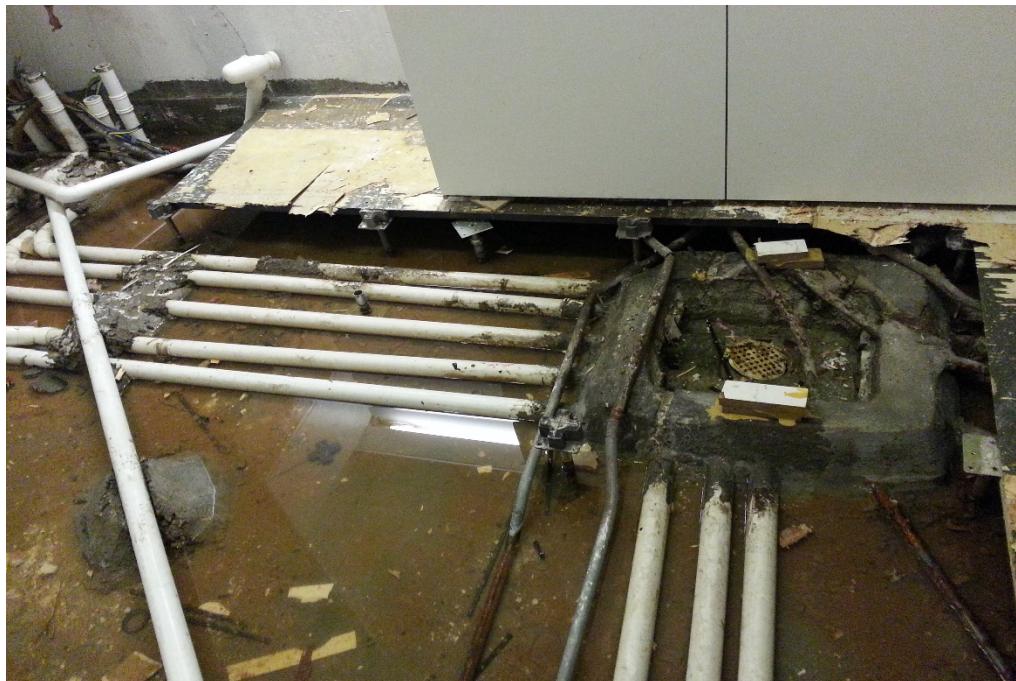
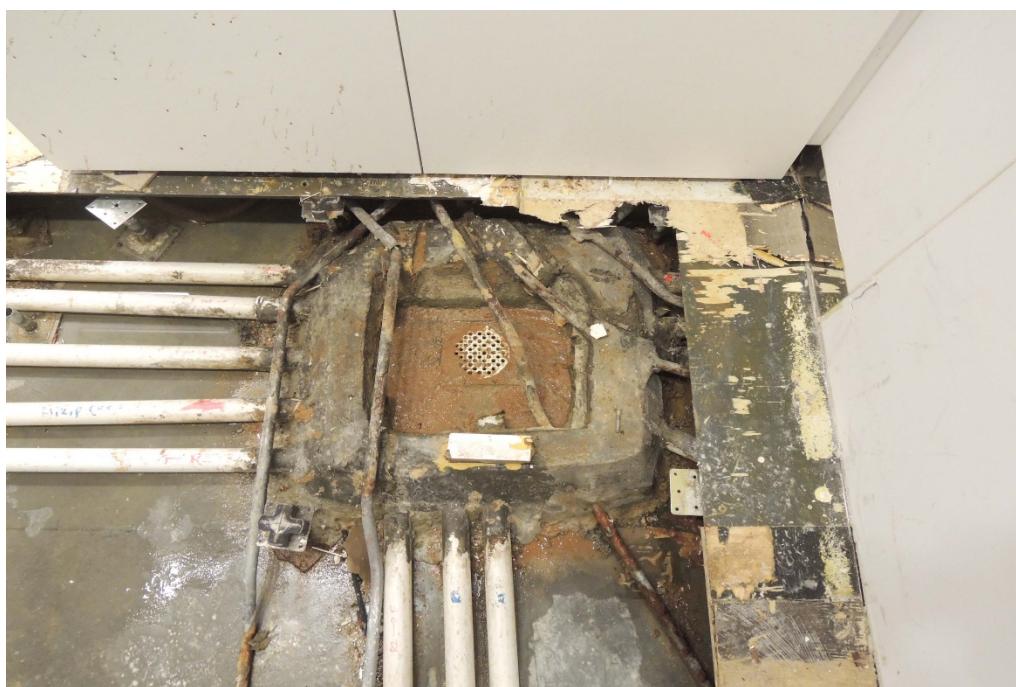
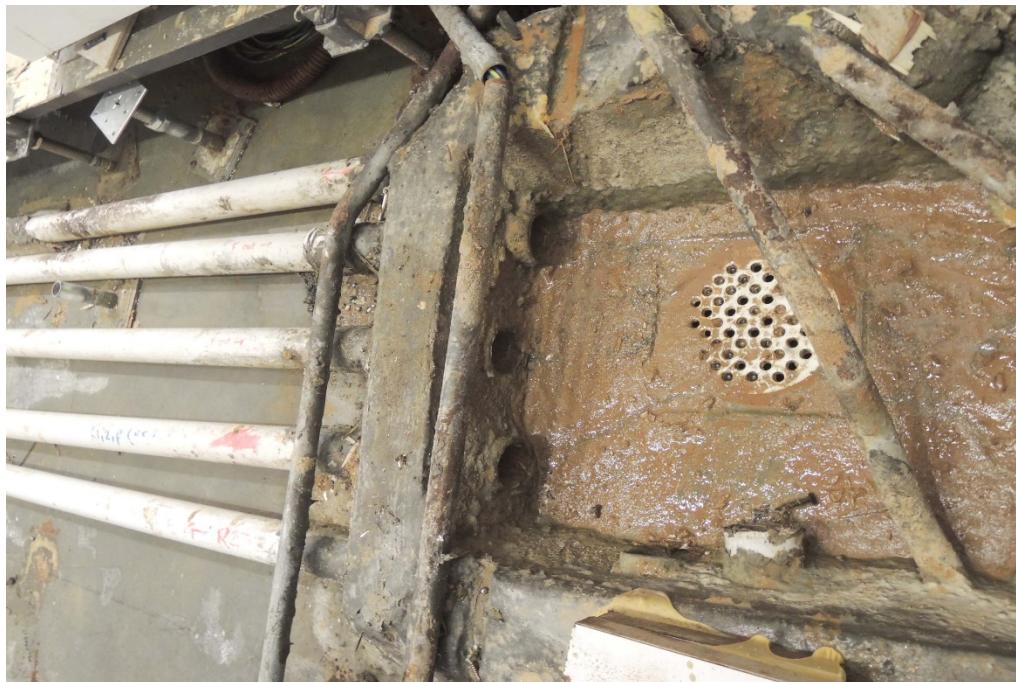
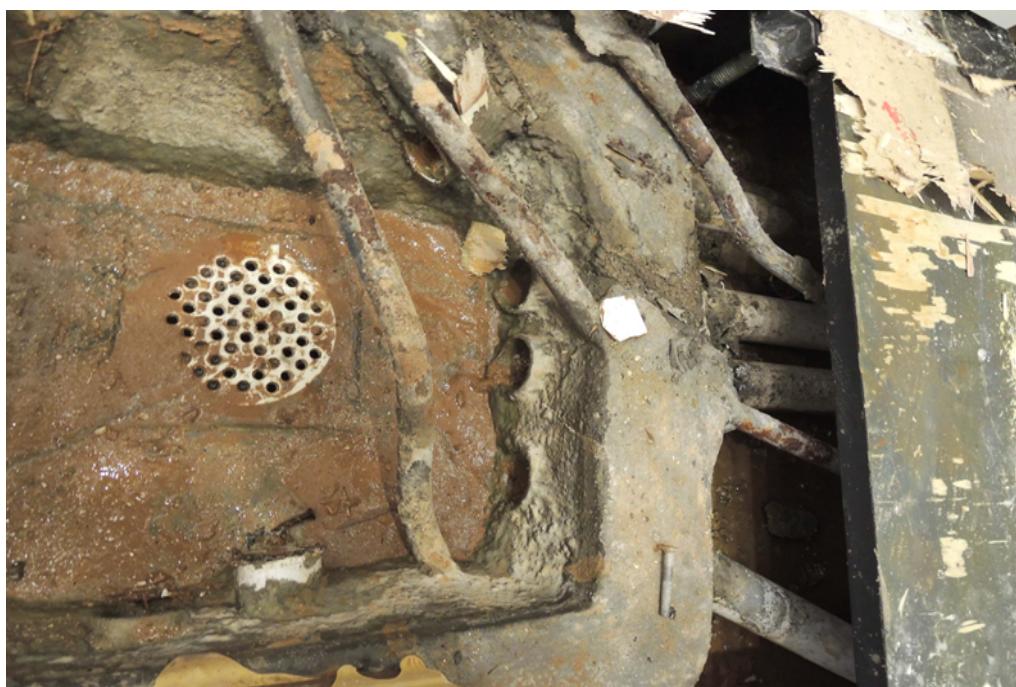
**Annex A**

(b) The drainage downpipe for water to be discharged out of the Suntec Clinic (the “Drainage Downpipe”) was situated in a raised bunded area (the “Bunded Area”). The Suntec Clinic produced debris, which clogged up the white circular plastic floor grating (the “Floor Grating”) that covered the Drainage Downpipe. This caused water to overflow the Bunded Area. (The Bunded Area is 340mm in length and 300mm in breadth, and is enclosed by a banded concrete wall 65mm in thickness and 100mm in height. The photographs in Annex A to this judgment show the Bunded Area.)

raised floor that the discharge pipes took, or how they were joined *before* reaching the Bunded Area, but in the design of the Bunded Area itself. In particular, as I explain below, the design was defective because the discharge outlets of the discharge pipes ended *above* the Floor Grating, and because the Floor Grating was included to begin with.

107 For the reasons stated above, I agree with the plaintiff's submission that terminating the nine discharge pipes *above* the Floor Grating, and at the raised Bunded Area, was a serious design flaw, which was the primary cause of the 1st and 2nd Floods. I find that no reasonable contractor would have provided for such a drainage system, which Dr Liew likened to a "death certificate signed" for flooding to occur.<sup>63</sup>

111 For all these reasons, I accept the plaintiff's submission that the flooding was primarily caused by (a) the termination of the outlets of all nine discharge pipes above the Floor Grating; and (b) the presence of the bunded walls, which prevented water outside the Bunded Area from draining into the Drainage Downpipe.

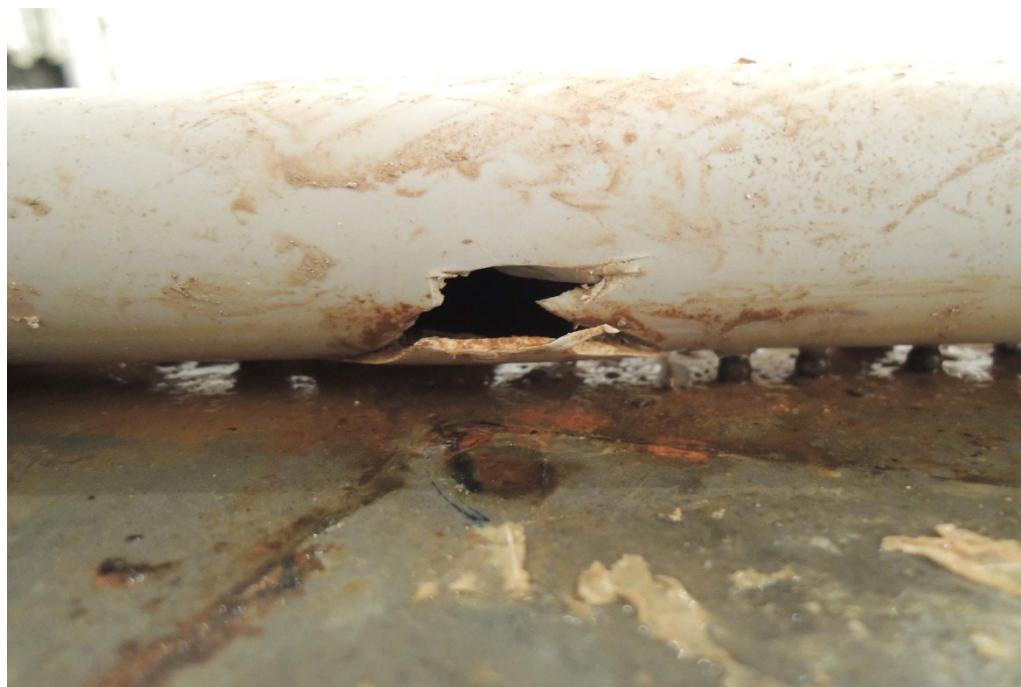
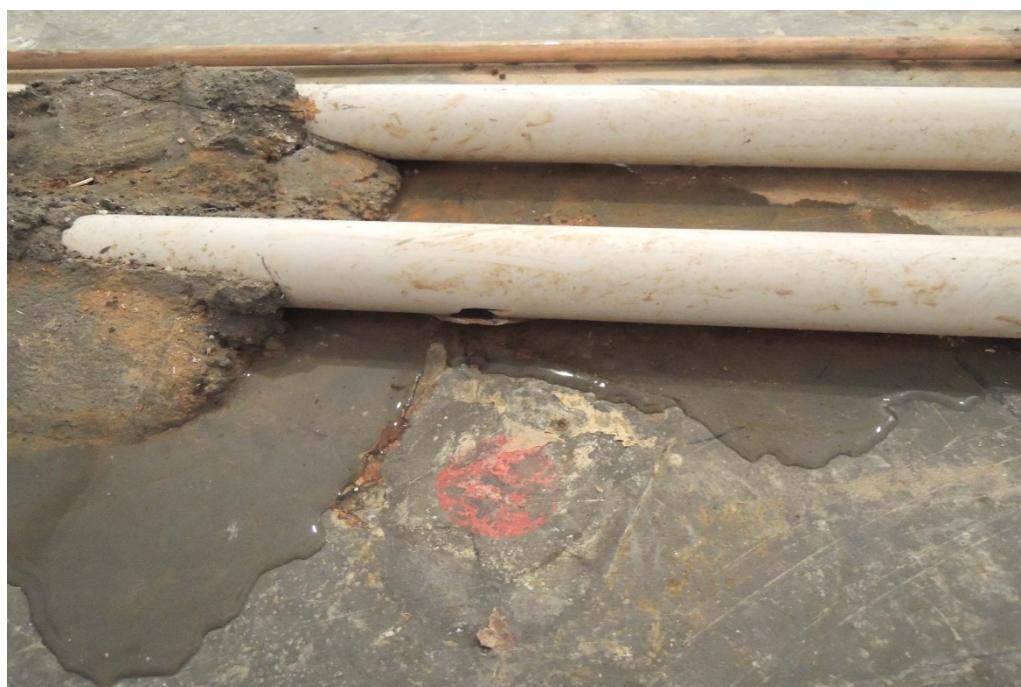
**Annex B**

- (a) leakage of water through the hole (see the photographs attached in Annex B to this judgment) in the waste water discharge pipe (the “Drainage Pipe”) from the dental chair in Surgery Room No 3 of the Suntec Clinic;
- (b) the design and installation of nine discharge pipes (the “discharge pipes”) whose discharge outlets were situated above the Floor Grating (see the photographs in Annex A to this judgment); and
- (c) the design and construction of the raised bunds, which prevented water that had overflowed the Bunded Area from draining into the Drainage Downpipe.

48 For the following reasons, I do not accept the plaintiff's allegation, set out in [46(a)] above, that the repeated flooding was caused by damage to the Drainage Pipe (attributable to the defendant). I find that the defendant did not damage the Drainage Pipe.

51 I therefore find that the water leakage test performed using the hydrostatic test method, which were conducted *prior to* the removal of the floor boards after the 2<sup>nd</sup> Flood, eliminates the possibility that there was a hole or puncture in the Drainage Pipe when the defendant *first* handed over the Suntec Clinic to the plaintiff. The Drainage Pipe, as shown in the photographs at Annex B, was thus not damaged by the defendant during its installation of the raised platform for the floor. I conclude that the Drainage Pipe must have been damaged during the removal of the pedestals and the raised floor platform *after* the 2<sup>nd</sup> Flood, by the plaintiff's own contractors. The flooding was accordingly not caused by leakage of waste water through the hole in the Drainage Pipe, as postulated by the plaintiff.
