**IN THE HIGH COURT OF THE REPUBLIC OF SINGAPORE**

**[2017] SGHC 246**

Suit No 498 of 2015

**JUDGMENT**

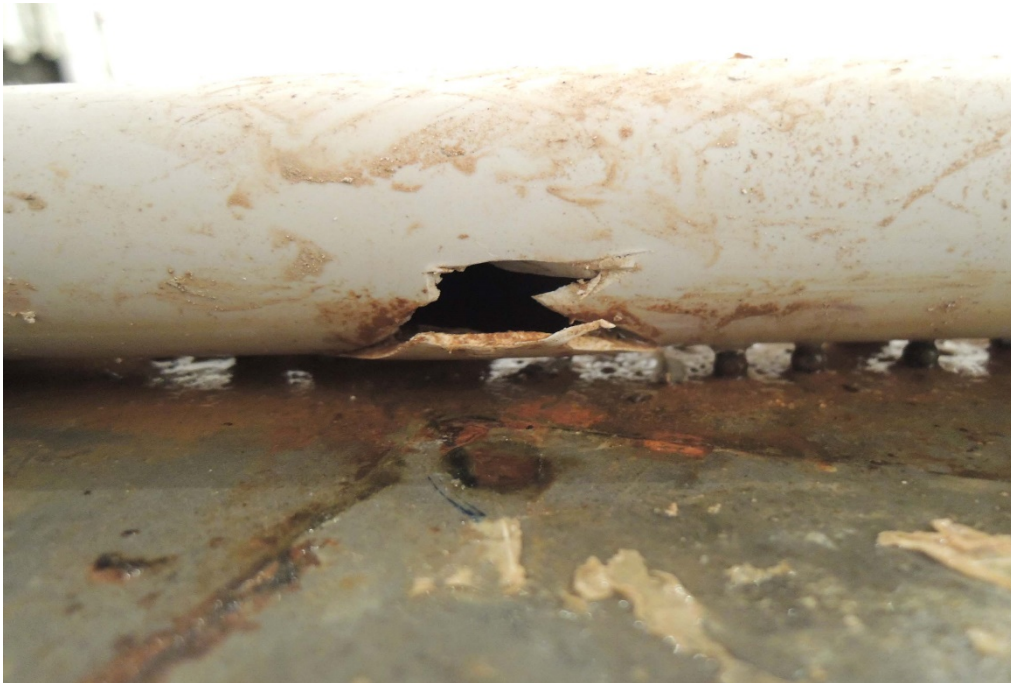
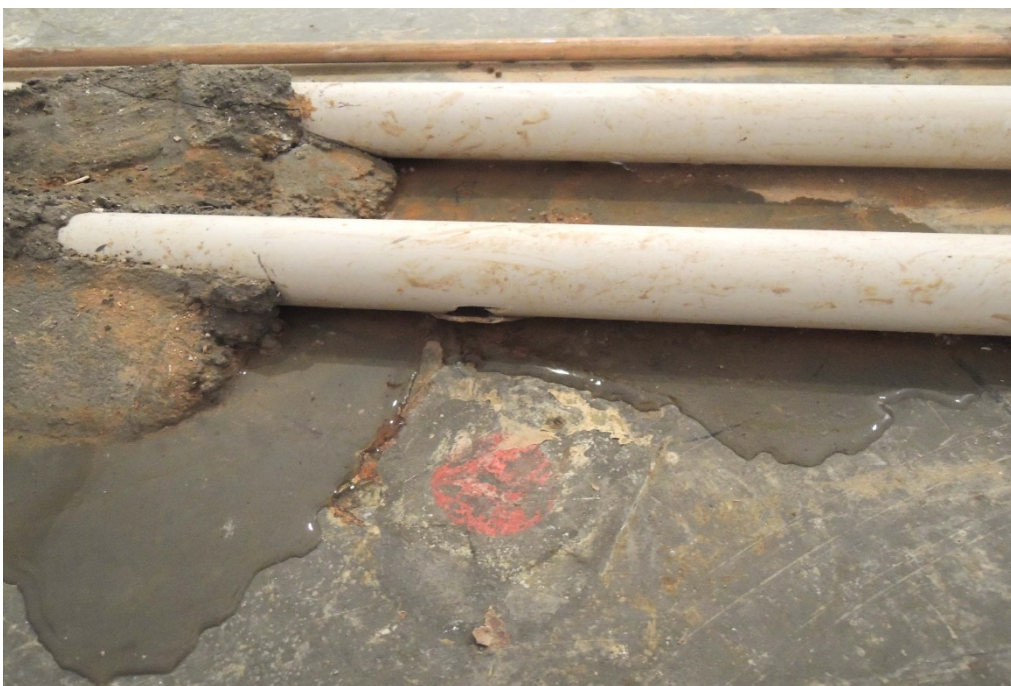
**Annex B**

- (a) leakage of water through the hole (see the photographs attached in Annex B to this judgment) in the waste water discharge pipe (the “Drainage Pipe”) from the dental chair in Surgery Room No 3 of the Suntec Clinic;
- (b) the design and installation of nine discharge pipes (the “discharge pipes”) whose discharge outlets were situated above the Floor Grating (see the photographs in Annex A to this judgment); and
- (c) the design and construction of the raised bunds, which prevented water that had overflowed the Bunded Area from draining into the Drainage Downpipe.

51 I therefore find that the water leakage test performed using the hydrostatic test method, which were conducted *prior to* the removal of the floor boards after the 2<sup>nd</sup> Flood, eliminates the possibility that there was a hole or puncture in the Drainage Pipe when the defendant *first* handed over the Suntec Clinic to the plaintiff. The Drainage Pipe, as shown in the photographs at Annex B, was thus not damaged by the defendant during its installation of the raised platform for the floor. I conclude that the Drainage Pipe must have been damaged during the removal of the pedestals and the raised floor platform *after* the 2<sup>nd</sup> Flood, by the plaintiff's own contractors. The flooding was accordingly not caused by leakage of waste water through the hole in the Drainage Pipe, as postulated by the plaintiff.
