IN THE COURT OF APPEAL OF THE REPUBLIC OF SINGAPORE

[2023] SGCA 20

Court of Appeal / Civil Appeal No 45 of 2022

[Admiralty and Shipping - Collision]

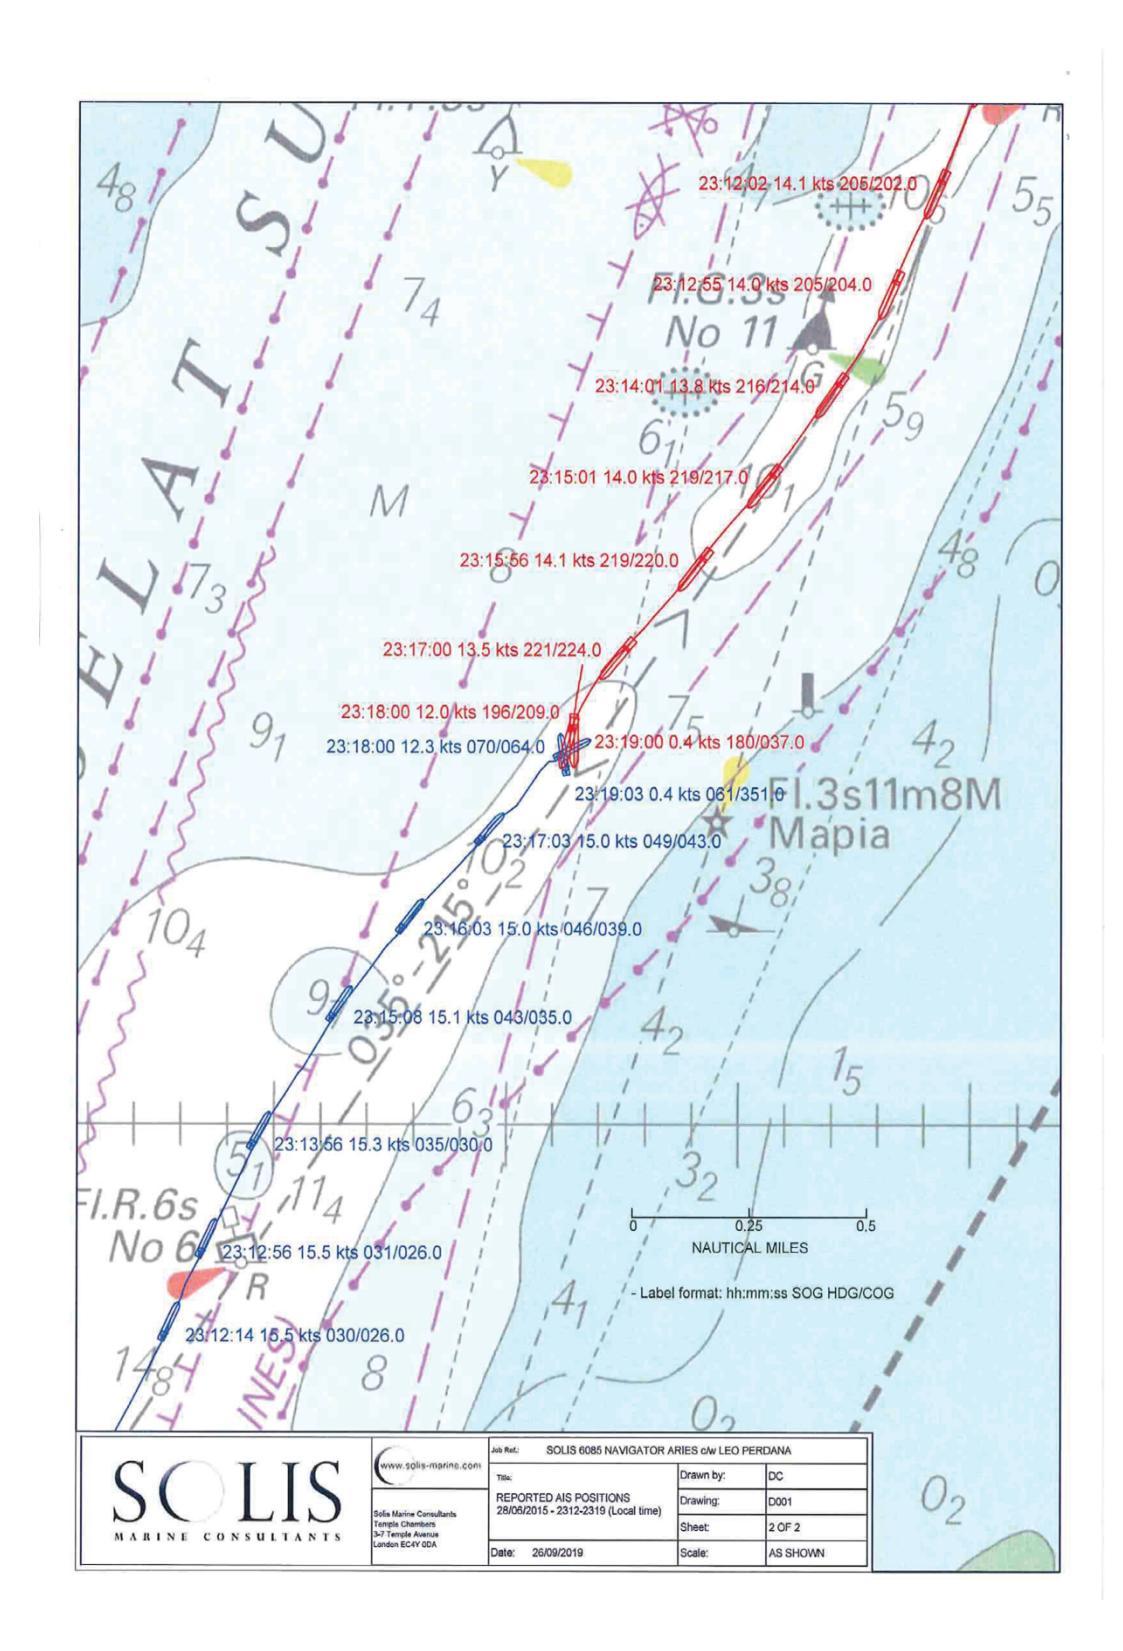
15 The period of the voyage starting from 23:12 hours is most relevant to the collision. The vessels' tracks for this period have been mapped out by the appellant's experts using the vessels' automatic identification system ("AIS") data (with the AIS heading data generated from each vessel's gyro compass):

32 The collision occurred at 23:17:51 hours, to the west of the Recommended Track (see the diagram at [15] above).

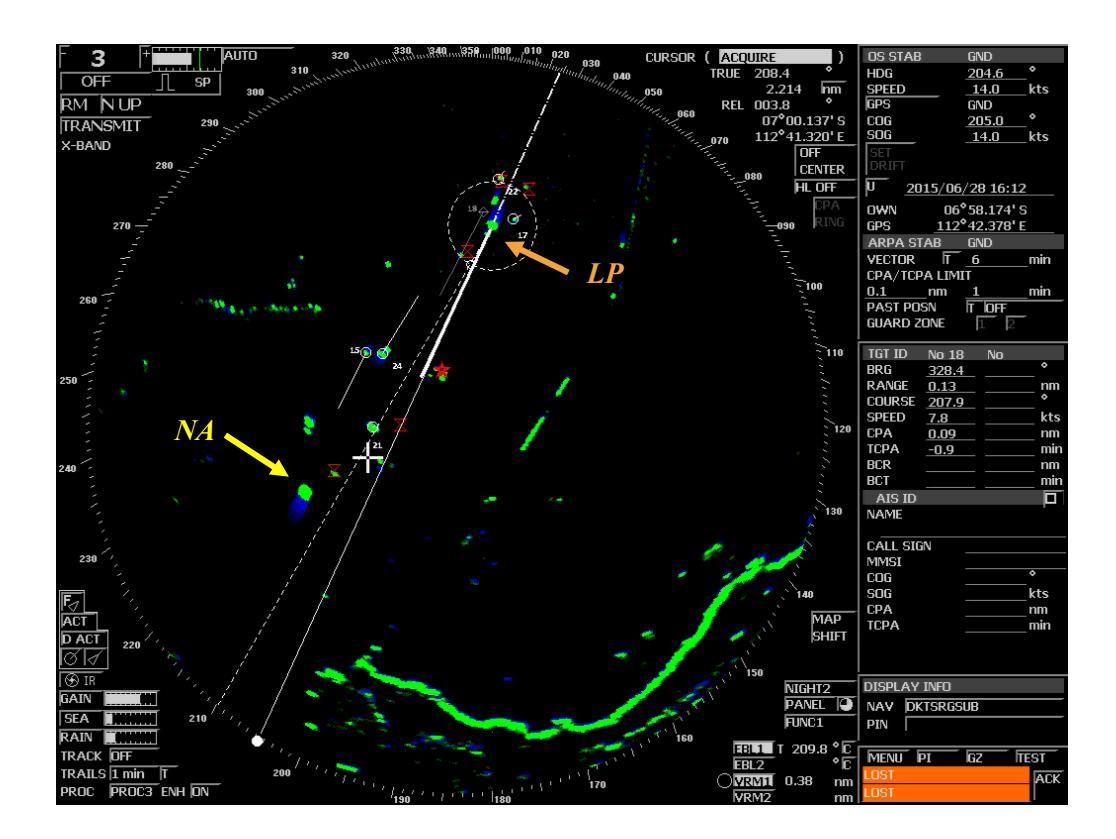
At this stage, each vessel was on the port side of the other's course over ground ("COG") line. This is illustrated partly by the following screengrab from the *LP*'s X-Band radar taken at 23:12:21 hours. To give effect to the port-toport passing agreement, it would have been clear that both vessels needed to make course alterations to starboard.

It should also be highlighted that the *NA* was already some distance to the west of the Recommended Track by this time (*ie*, by 23:12 hours). We will return to the significance of this at [177] and [193] below.

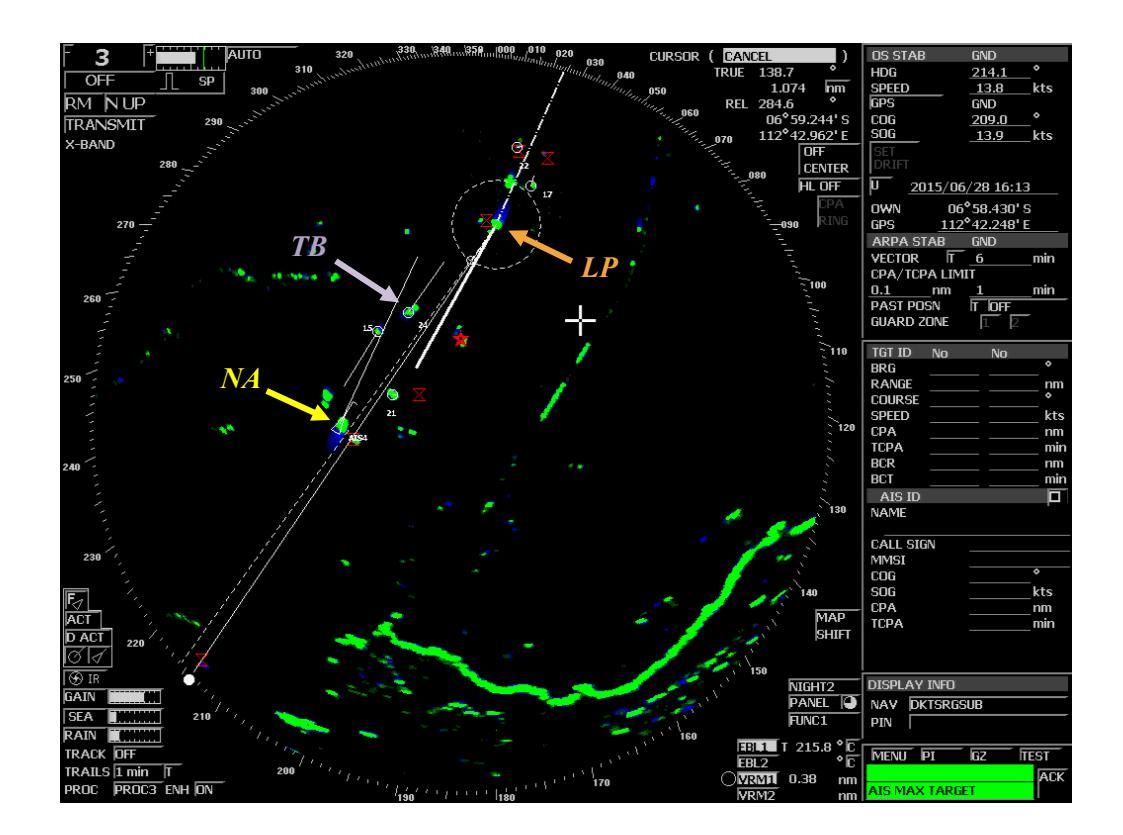
31 The following screengrab from the LP's X-Band radar, taken at 23:13:36 hours, reflects the relative positions of the vessels when the starboard-tostarboard passing agreement was reached with the *TB*:

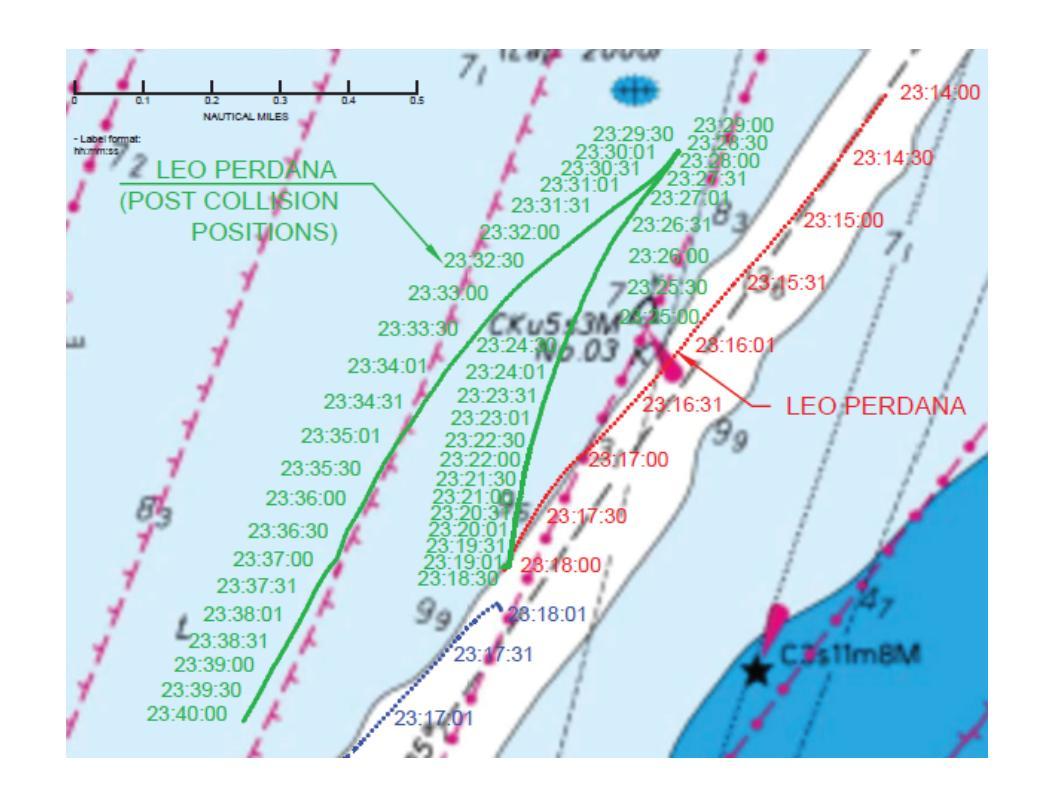
139 We address each observation in turn, starting with the LP's postcollision track. Using the LP's AIS positions, the appellant's experts had mapped out her post-collision track as follows (in green):

We mention for completeness that this map does not reflect the Strait's bathymetry *post*-dredging. It is based on BA Chart 975, which was published in 2012 prior to the dredging activity in 2015. However, nothing really turns on this observation in our analysis of Rule 9, although we will return to this in relation to Rule 2 (see [158] below).

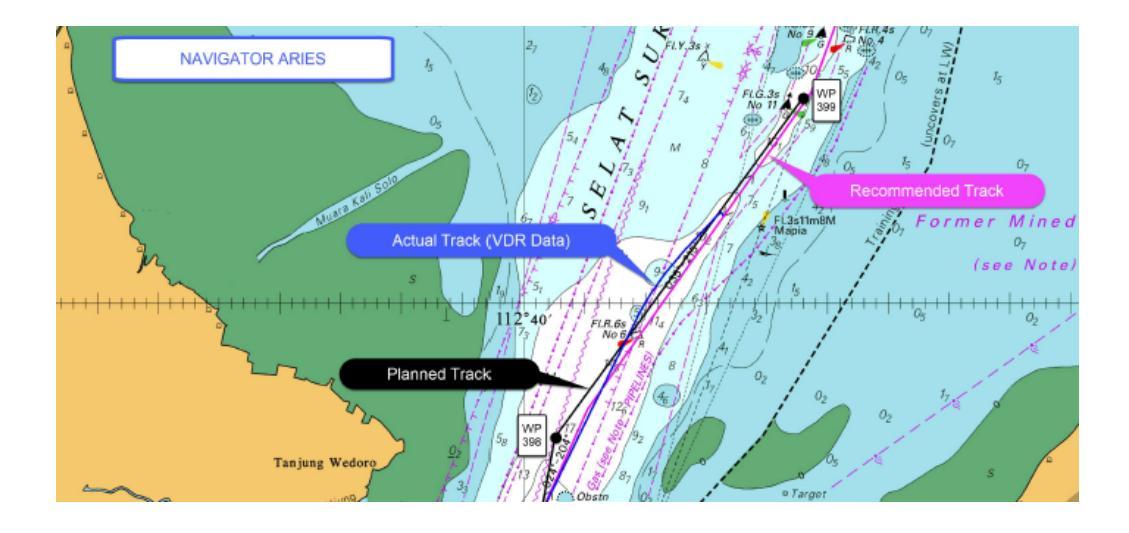
177 At about 23:10 hours, the *NA* reached the charted point where the axis of the Recommended Track changed from 024° to 035° (see the diagram at [178] below). But the *NA* did not adjust her course to starboard, and kept her COG around 026° – some 9° port off the Recommended Track. She remained to the west of the Recommended Track up to the time of collision. Comparing her heading and COG, it appeared that she was unable to overcome a drift angle of some 6° to port due to the prevailing northerly current.

178 From the following chart prepared by Capt Hart, it can be seen that the *NA*'s actual track (in blue) cut across that of the Recommended Track (in pink) as she travelled northwards, with her actual track remaining to the west of the Recommended Track up to the point of collision (where the blue line terminates):

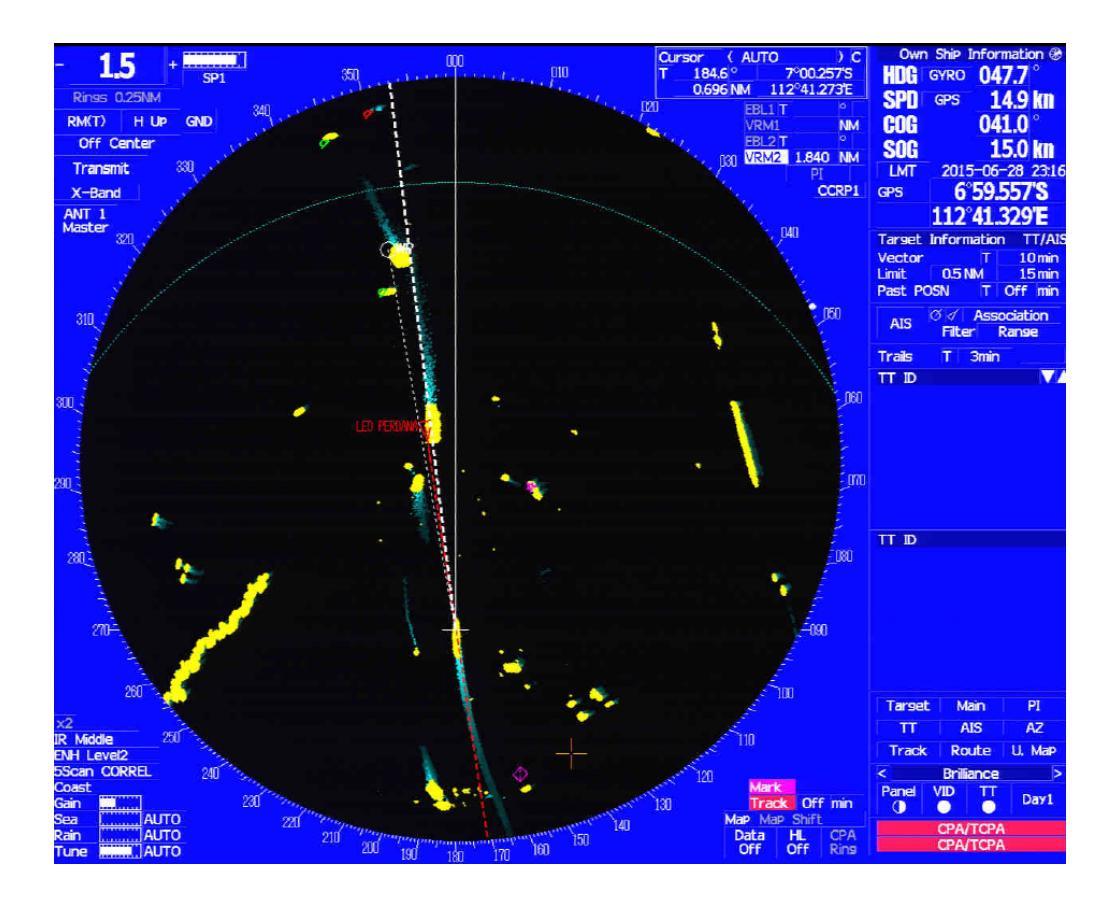
196 From their courses, the vessels also appeared to be shaping to complete the red-to-red passing. As described above at [101], the vessels' red sidelights had opened and green sidelights had closed by 23:15 to 23:16 hours, indicating that each vessel was off the other's port bow. The point is made starker when one compares the following radar screengrabs from the NA's X-Band radar (which is set to head-up mode with relative motion, and a 1.5nm range). The first screengrab, taken at 23:16:14 hours, shows the LP's radar echo lying on the NA's COG line (*ie*, the white dashed line extending from the NA).

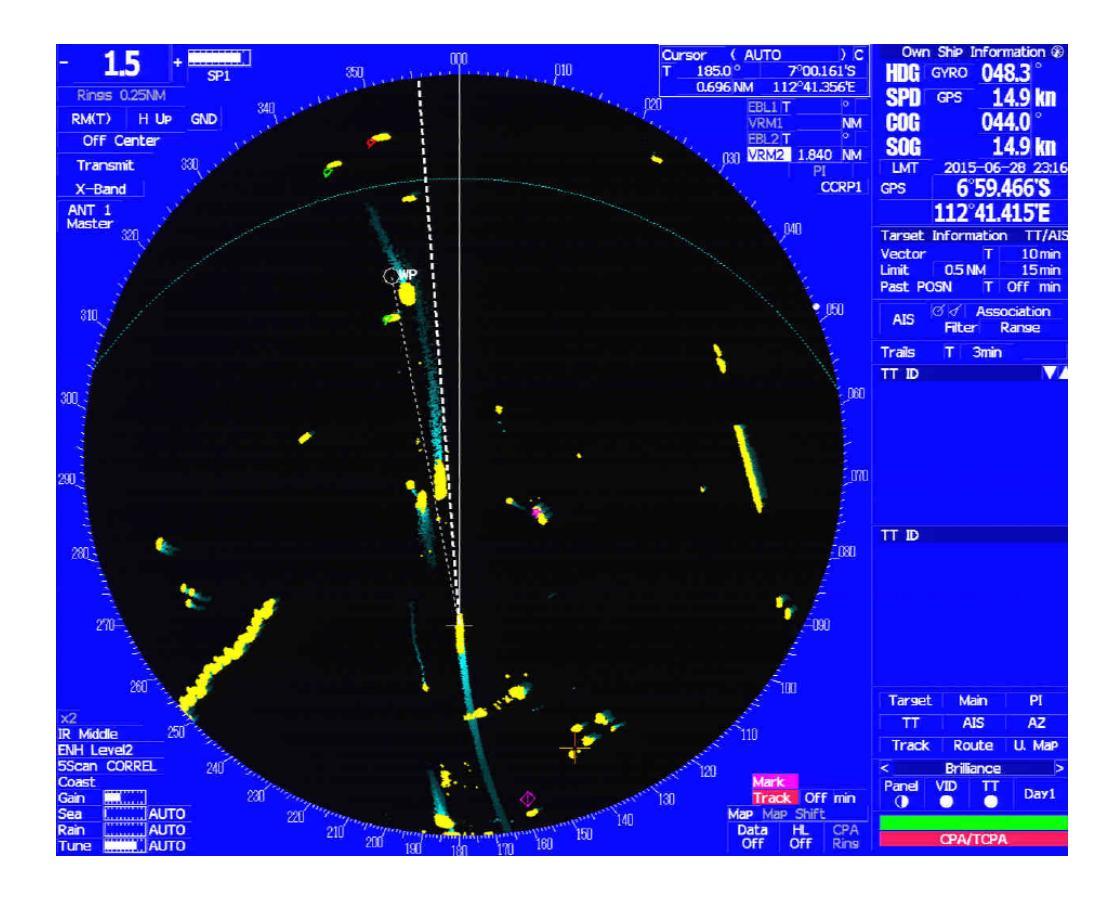
197 The screengrab taken 30 seconds later at 23:16:44 hours (reproduced below) shows the *LP*'s radar echo now lying *port* of the *NA*'s COG line, as vessels shaped to pass port-to-port. This was just before the port sheer commenced at 23:16:46 hours.
