**IN THE GENERAL DIVISION OF
THE HIGH COURT OF THE REPUBLIC OF SINGAPORE**

[2022] SGHC 32

District Court Appeal No 25 of 2021

JUDGMENT

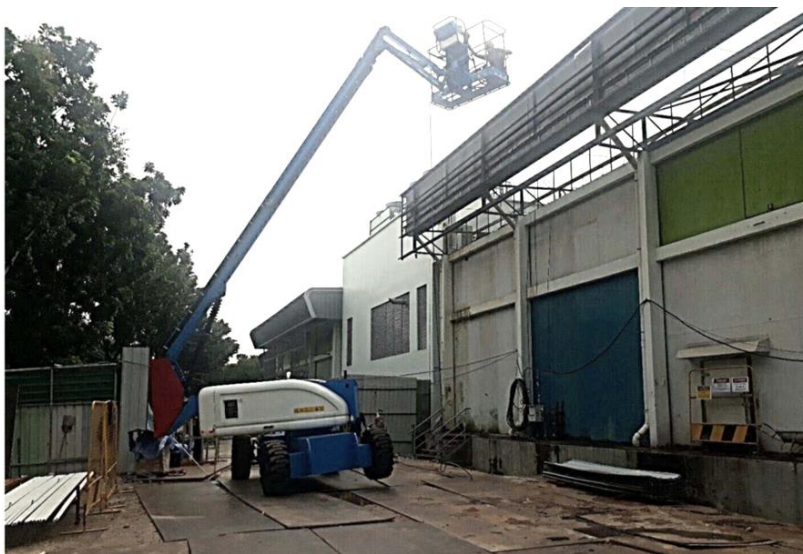
8 A photograph was taken and put into evidence during the trial. It is reproduced here:¹⁰

9 I shall refer to this photograph as the tilting incident photograph. It shows the Boom Lift after it had shut off and before the workers were rescued. Only the upper boom had been deployed. It had been elevated to an angle of about 45 to 50 degrees. One wheel had lost contact with the ground.

11 Three days after the incident, and after the Boom Lift had been stowed, the buyer complained by email dated 31 January 2018 that the Boom Lift was “unsafe for use” and requested that the seller rectify the problem.¹² The email attached the tilting incident photograph, among others.

21 The district judge in *Debenho Pte Ltd v Ten League Corporations Pte Ltd* [2021] SGDC 199 found for the buyer and allowed its claim for a full refund of the purchase price. He held that the buyer had produced *prima facie* evidence that the Boom Lift was unsafe to use, namely the tilting incident photograph

24 The seller contended that the tilting incident photograph showed that the upper boom had been used at, or close to, the maximum angle without deploying the lower boom.³⁴ Therefore, the tilting incident photograph did not of itself amount to *prima facie* evidence of any defect in the Boom Lift. As for the cautionary note sounded in the seller's email of 7 February 2018, this did not constitute an admission that the Boom Lift was unsafe to use or of unsatisfactory quality. It was just prudent and responsible advice.³⁵ When Mr Jia carried out his inspections, he did not find anything wrong with the Boom Lift. Installing the angle sensors did not impair the use of the Boom Lift, but only helped to ensure that the operator would not overextend the upper boom prior to deploying the lower boom.³⁶
